FY05 Forest Service Aviation Accident Review

NTSB Identification: **DFW05FA086**

NTSB Identification: **DEN05TA113**

NTSB Identification: **LAX05GA243**

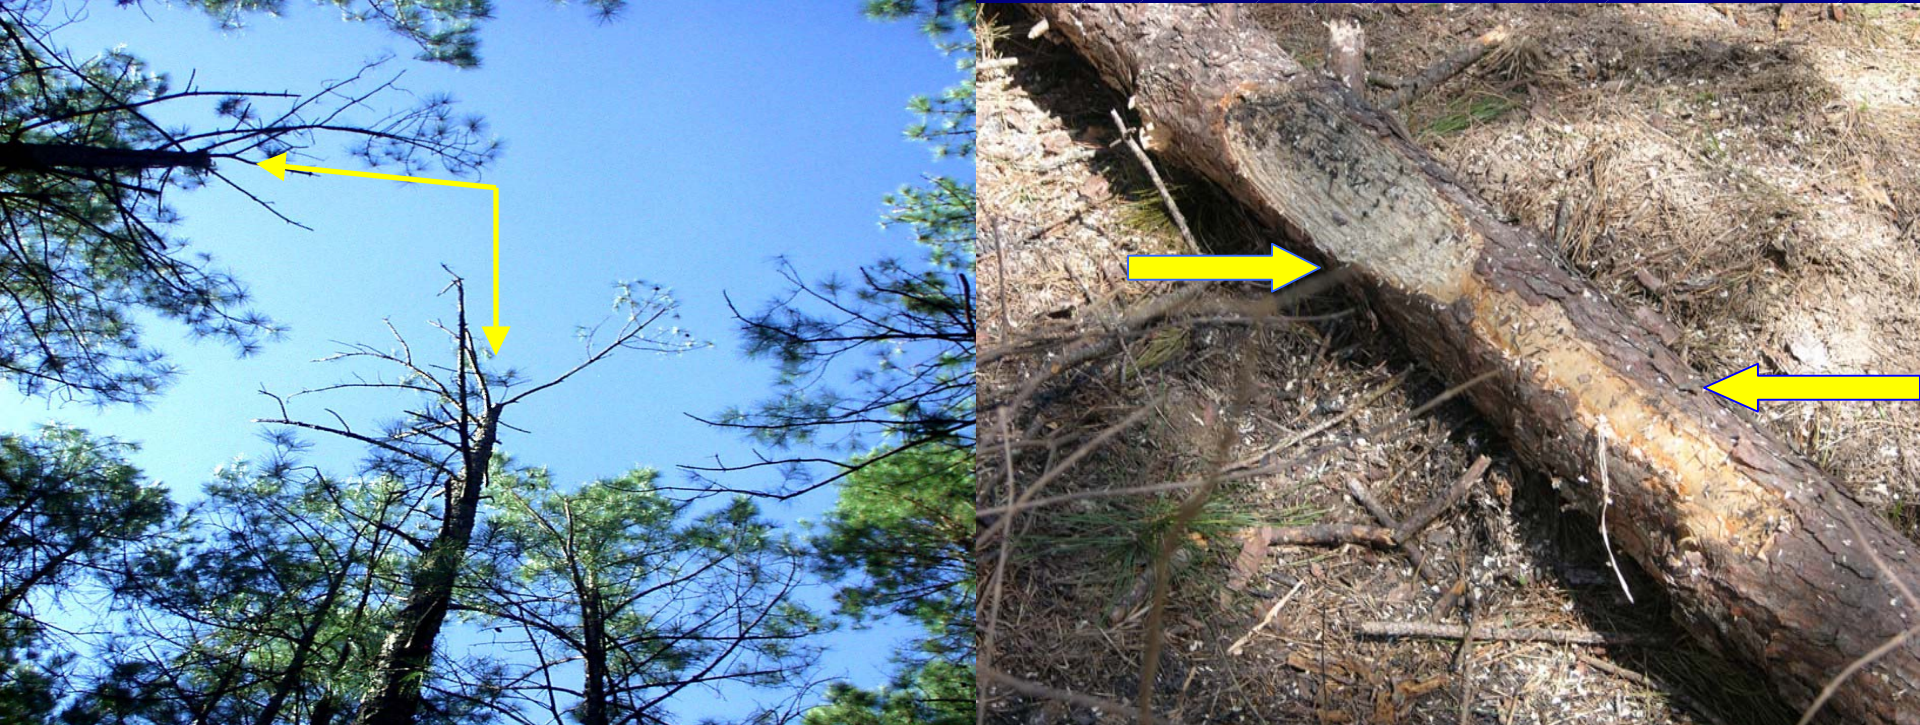
Prominent damage on only a few trees indicates steep vertical descent, two trees shown here.

This tree was cut down in order to better observe the blade strike/scarring

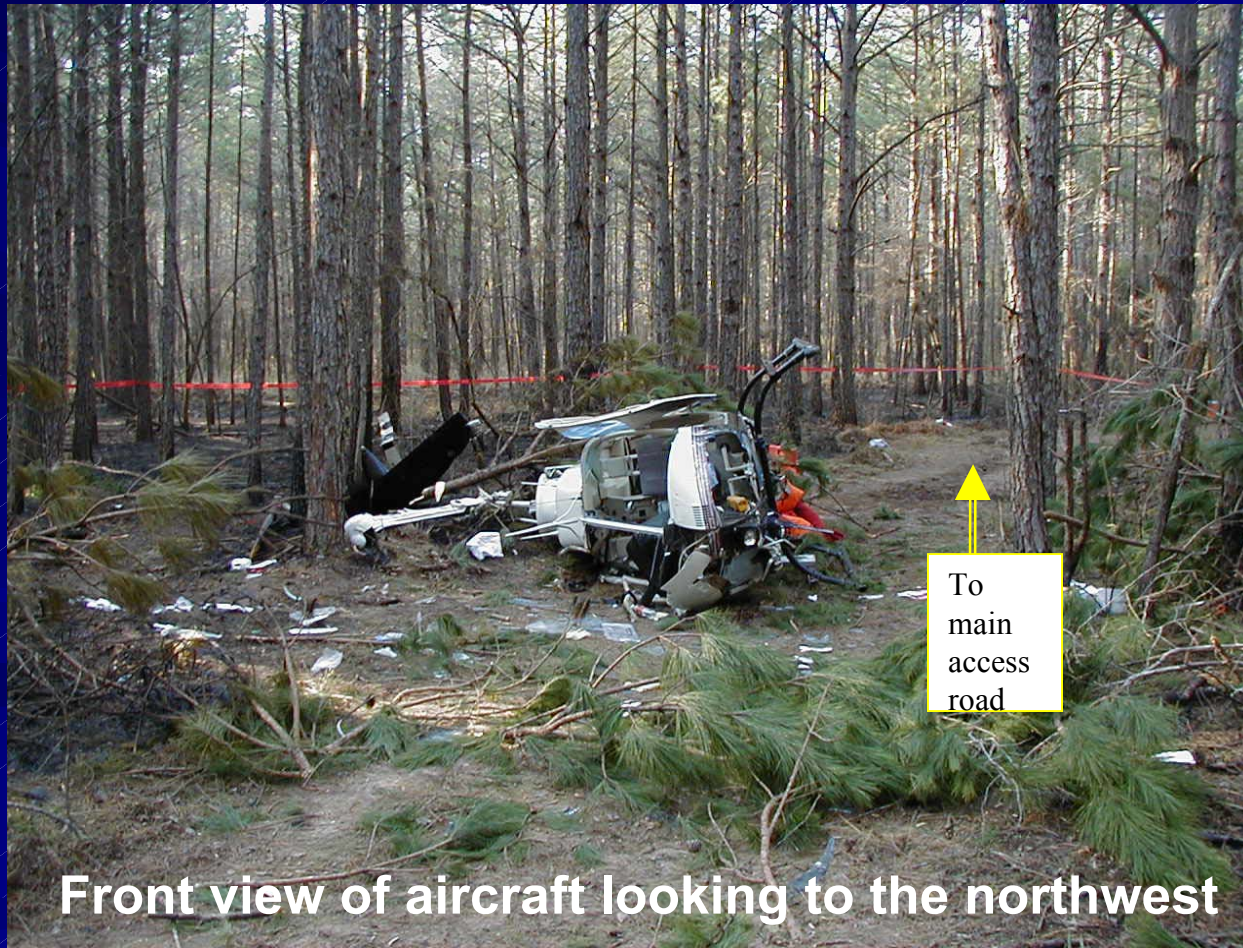
Front view of aircraft looking to the northwest

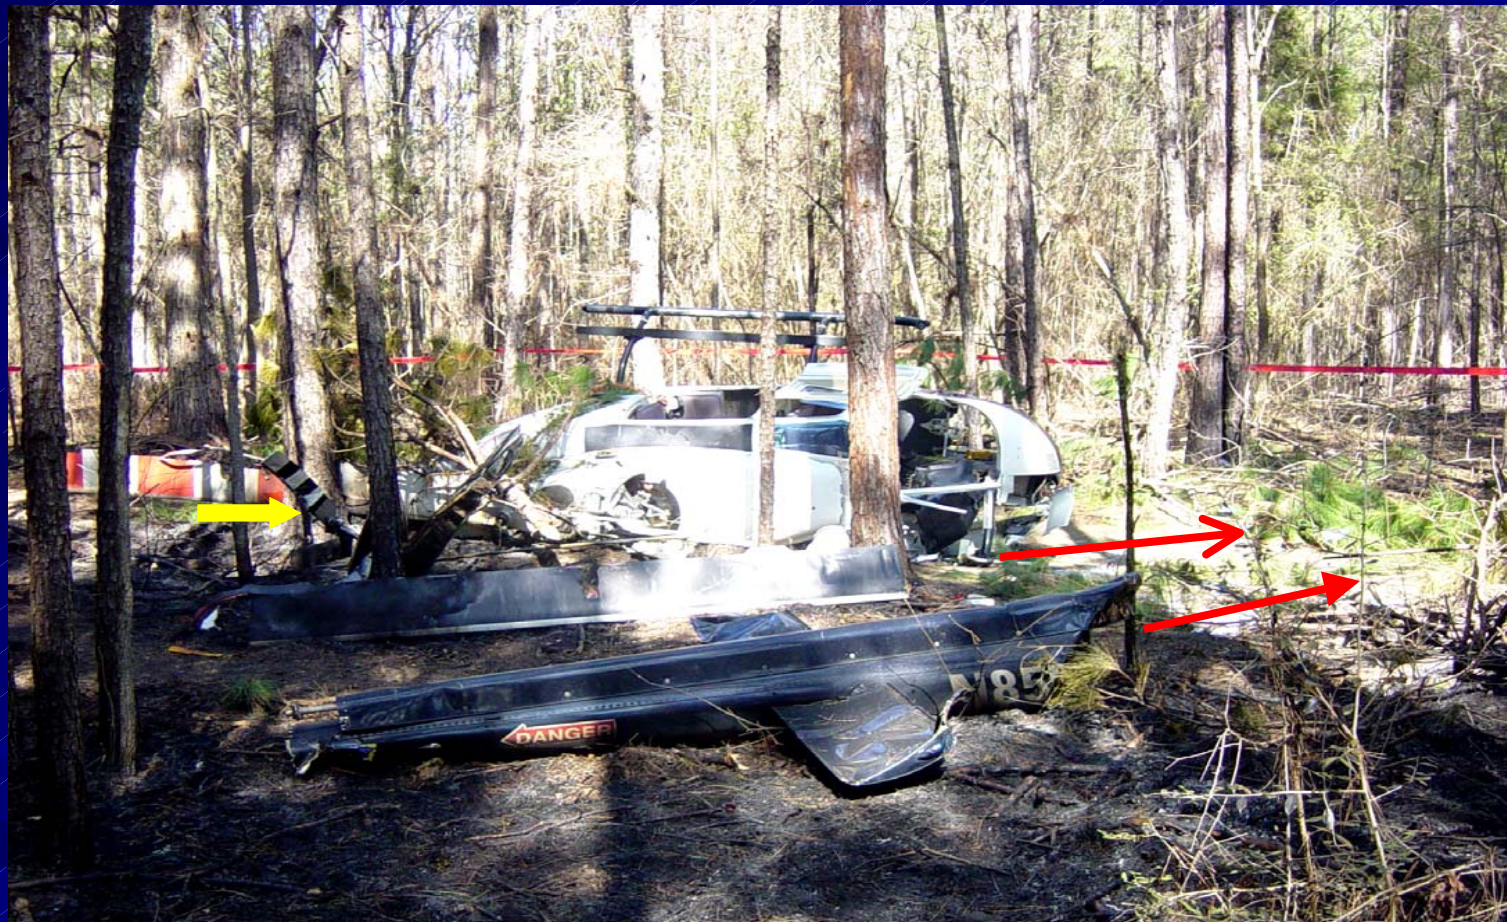
Rotor blade in foreground and tail boom were located in front of the helicopter prior to rescue efforts. Note position of tail rotor assembly (yellow arrow)

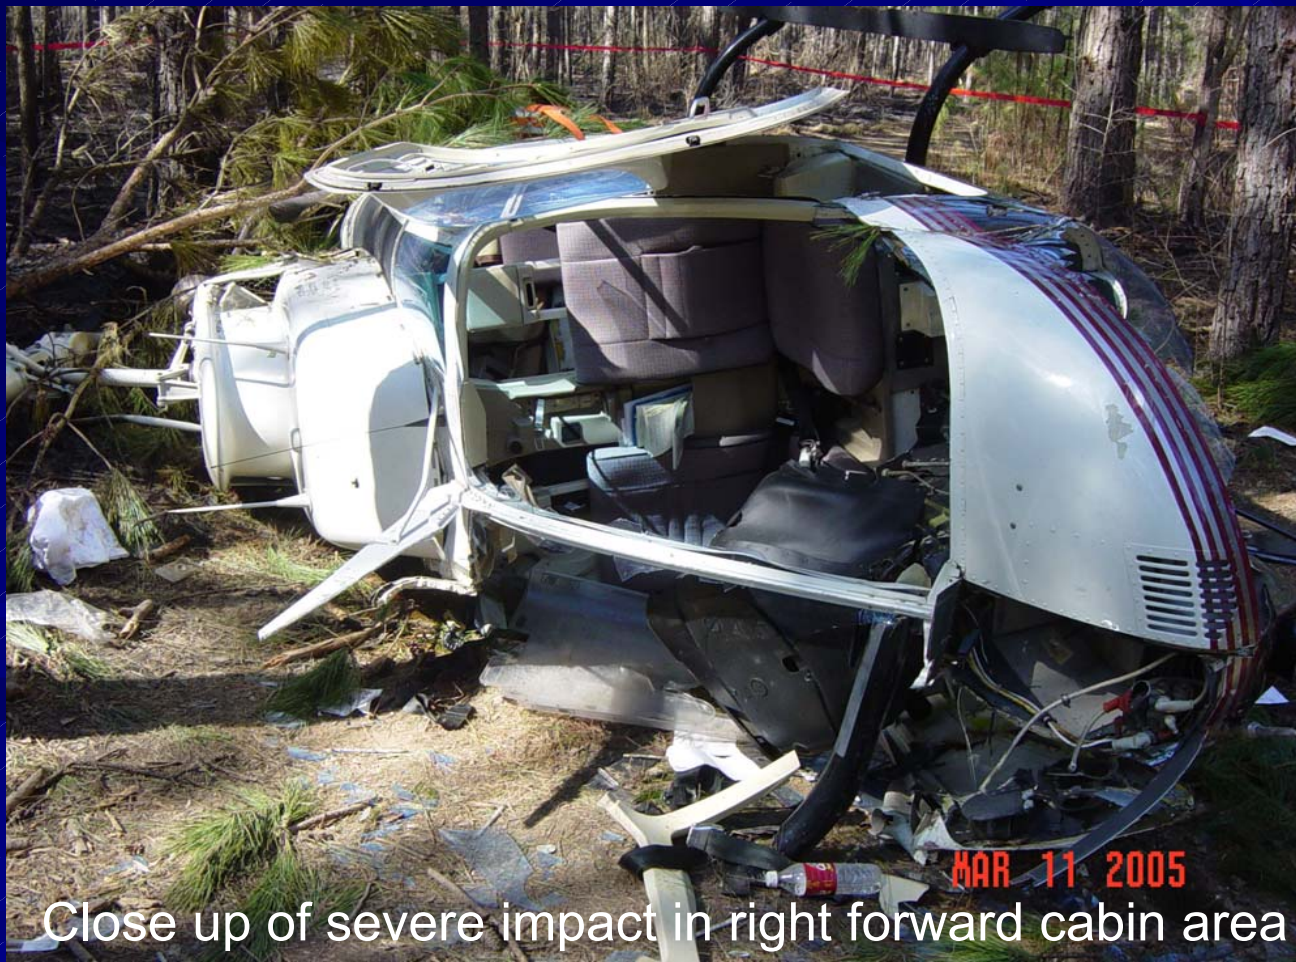
Close up of severe impact in right forward cabin area

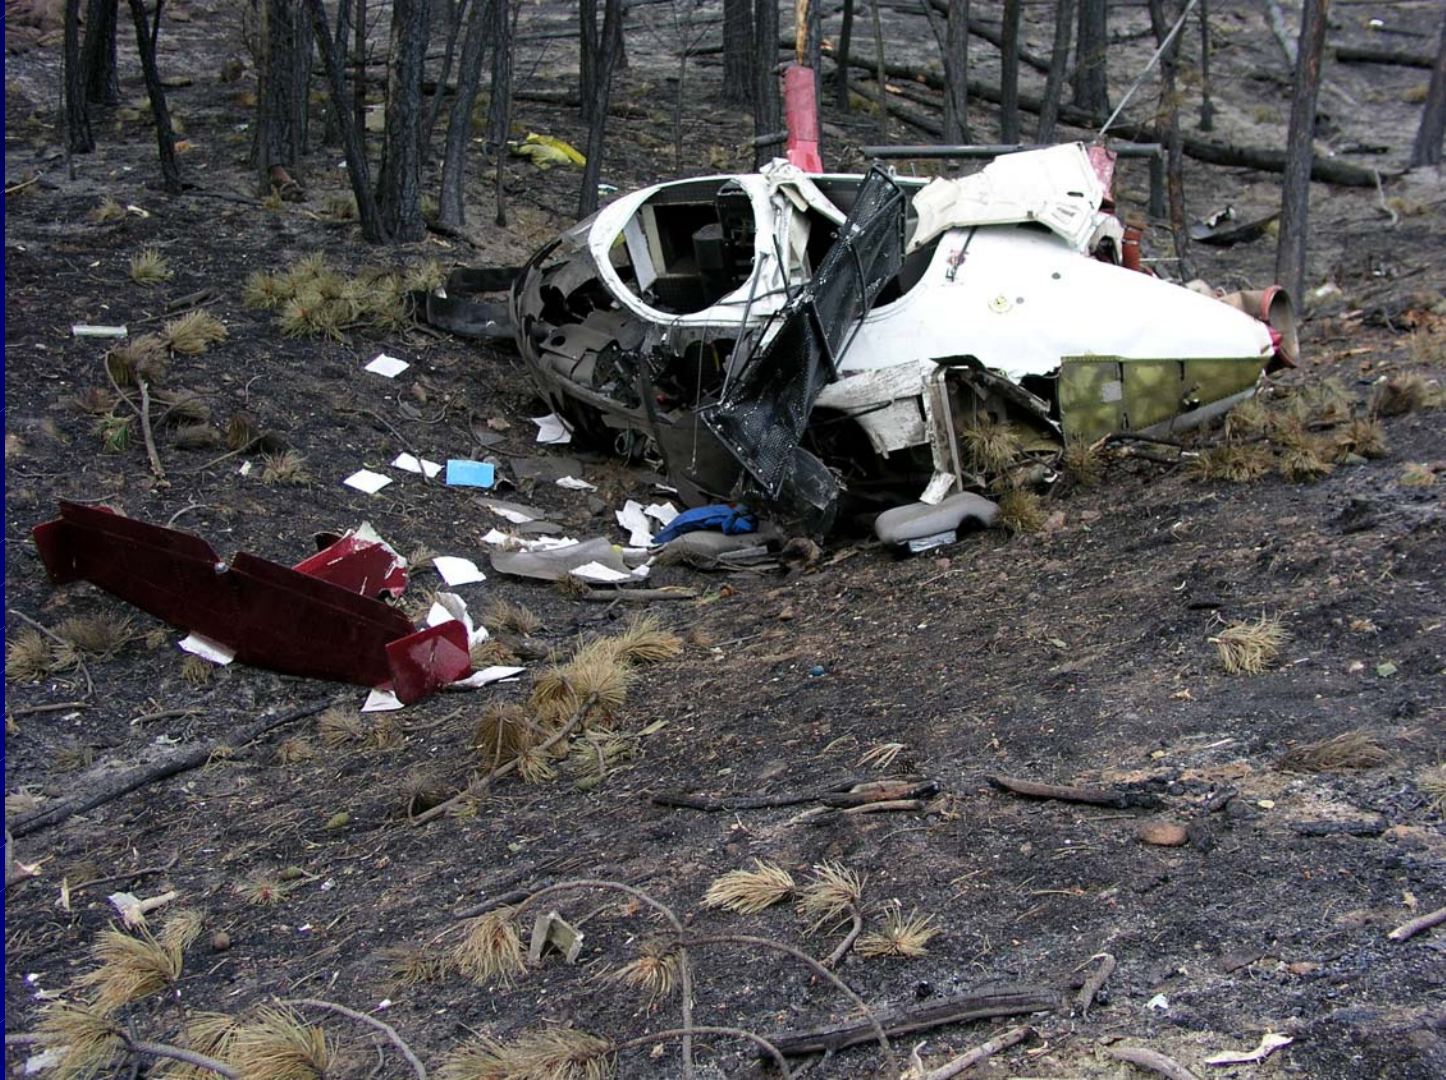
Subsequently, the helicopter impacted terrain and came to rest on its left side. Prior to or during the uncommanded right yaw, the pilot did not observe any visual warnings or hear any aural warnings in the helicopter.

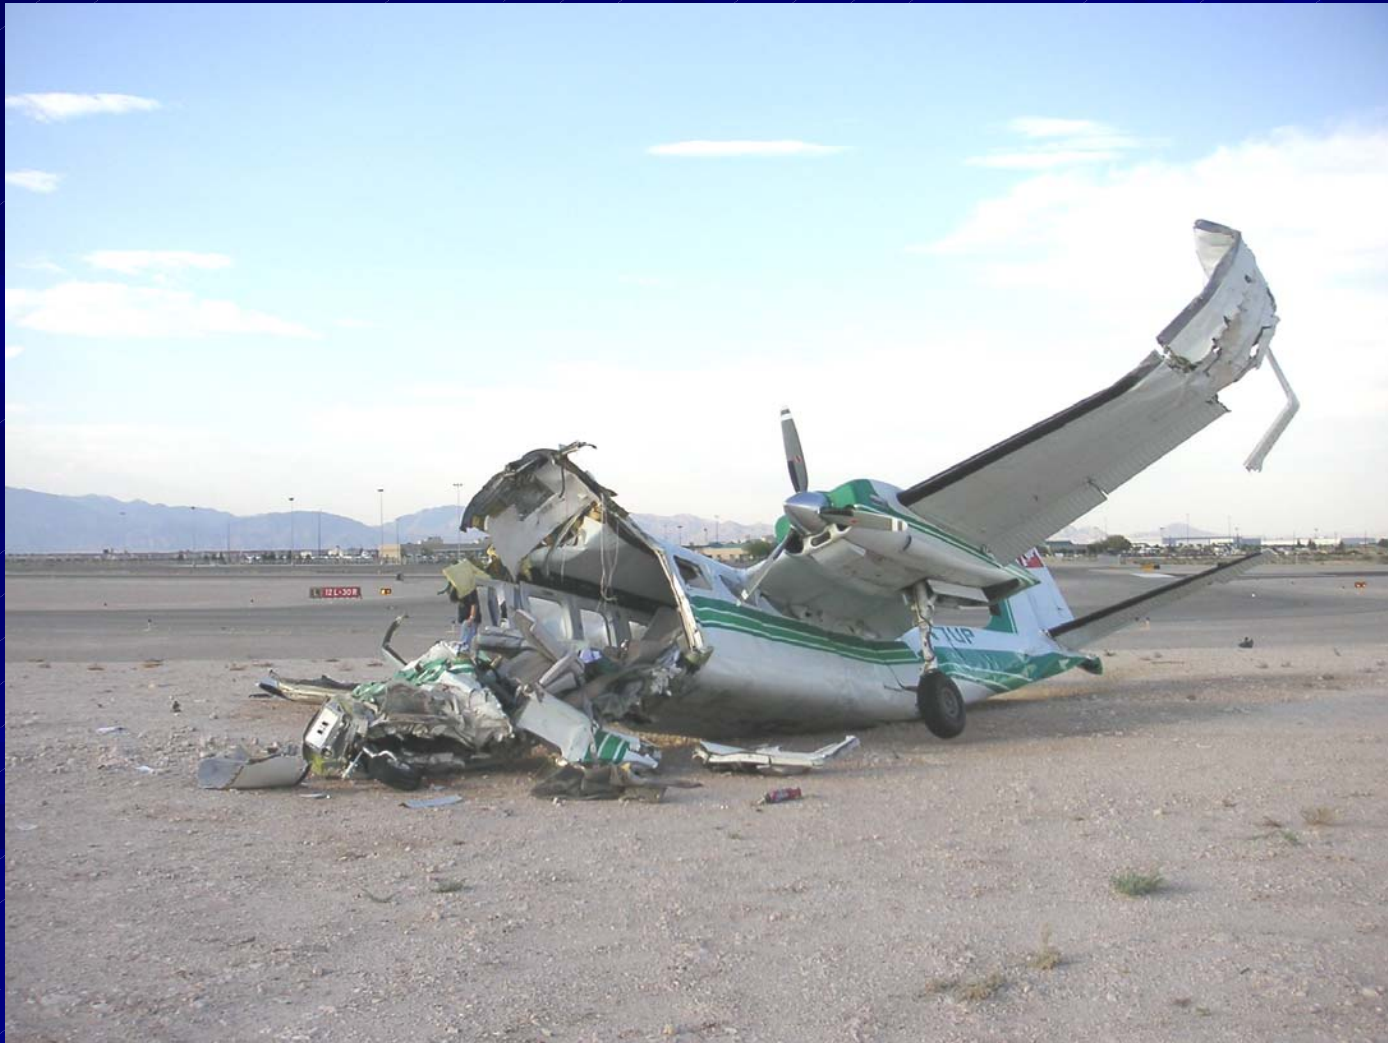
The flaps were measured to be at the 30-degree position. The flap actuator was measured and also corresponded to a 30-degree position. The flap indicator was damaged in the impact sequence but indicated the flaps were in the 30-degree position.

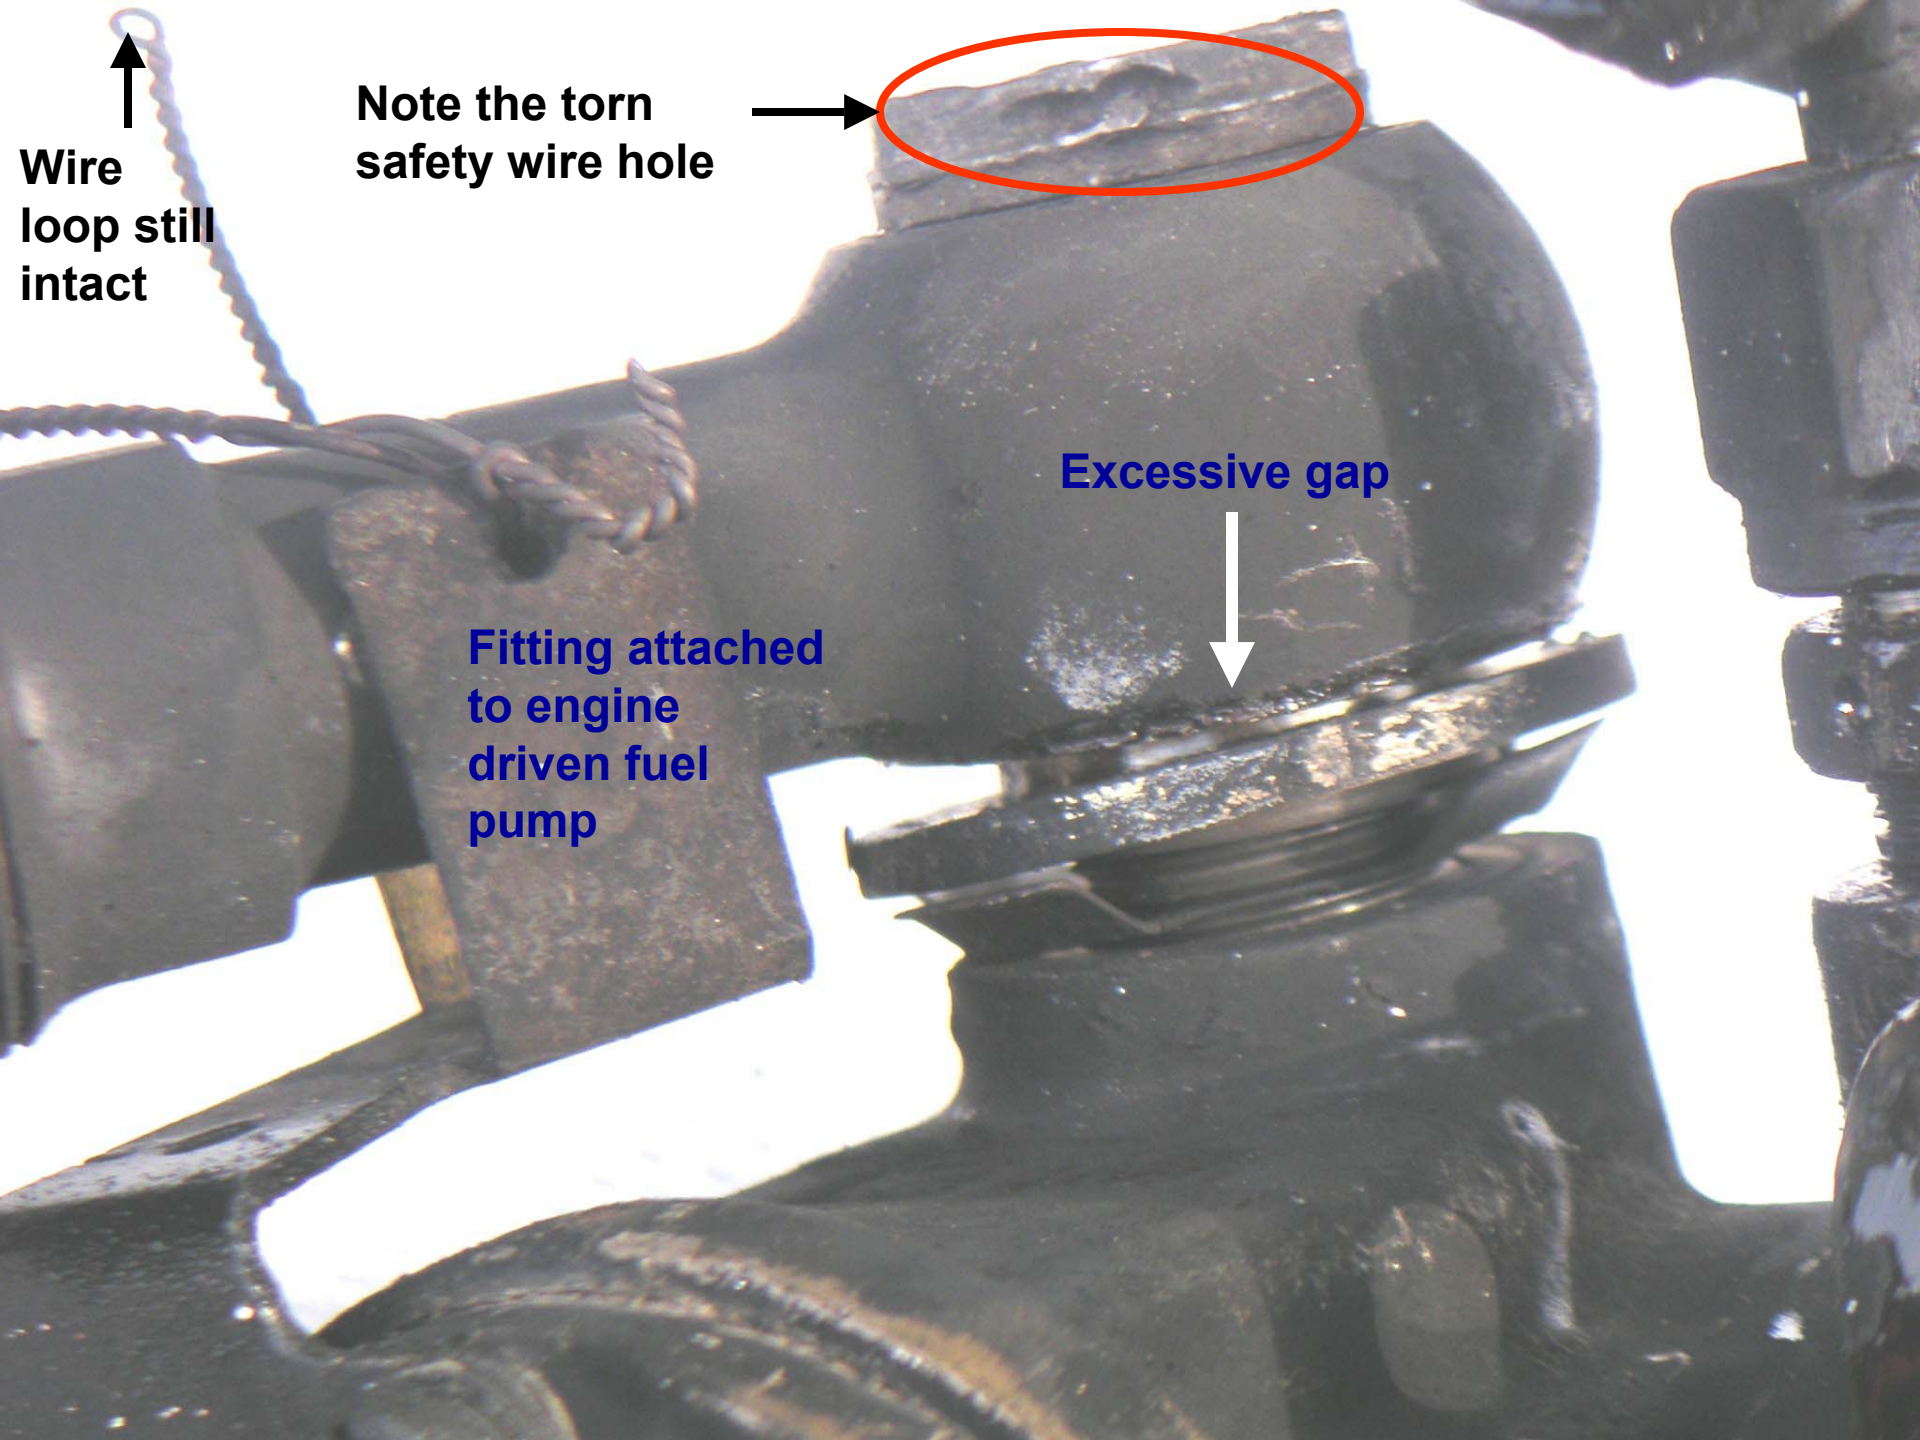
Wire
loop still
intact

Note the torn
safety wire hole

Excessive gap

Fitting attached
to engine
driven fuel
pump

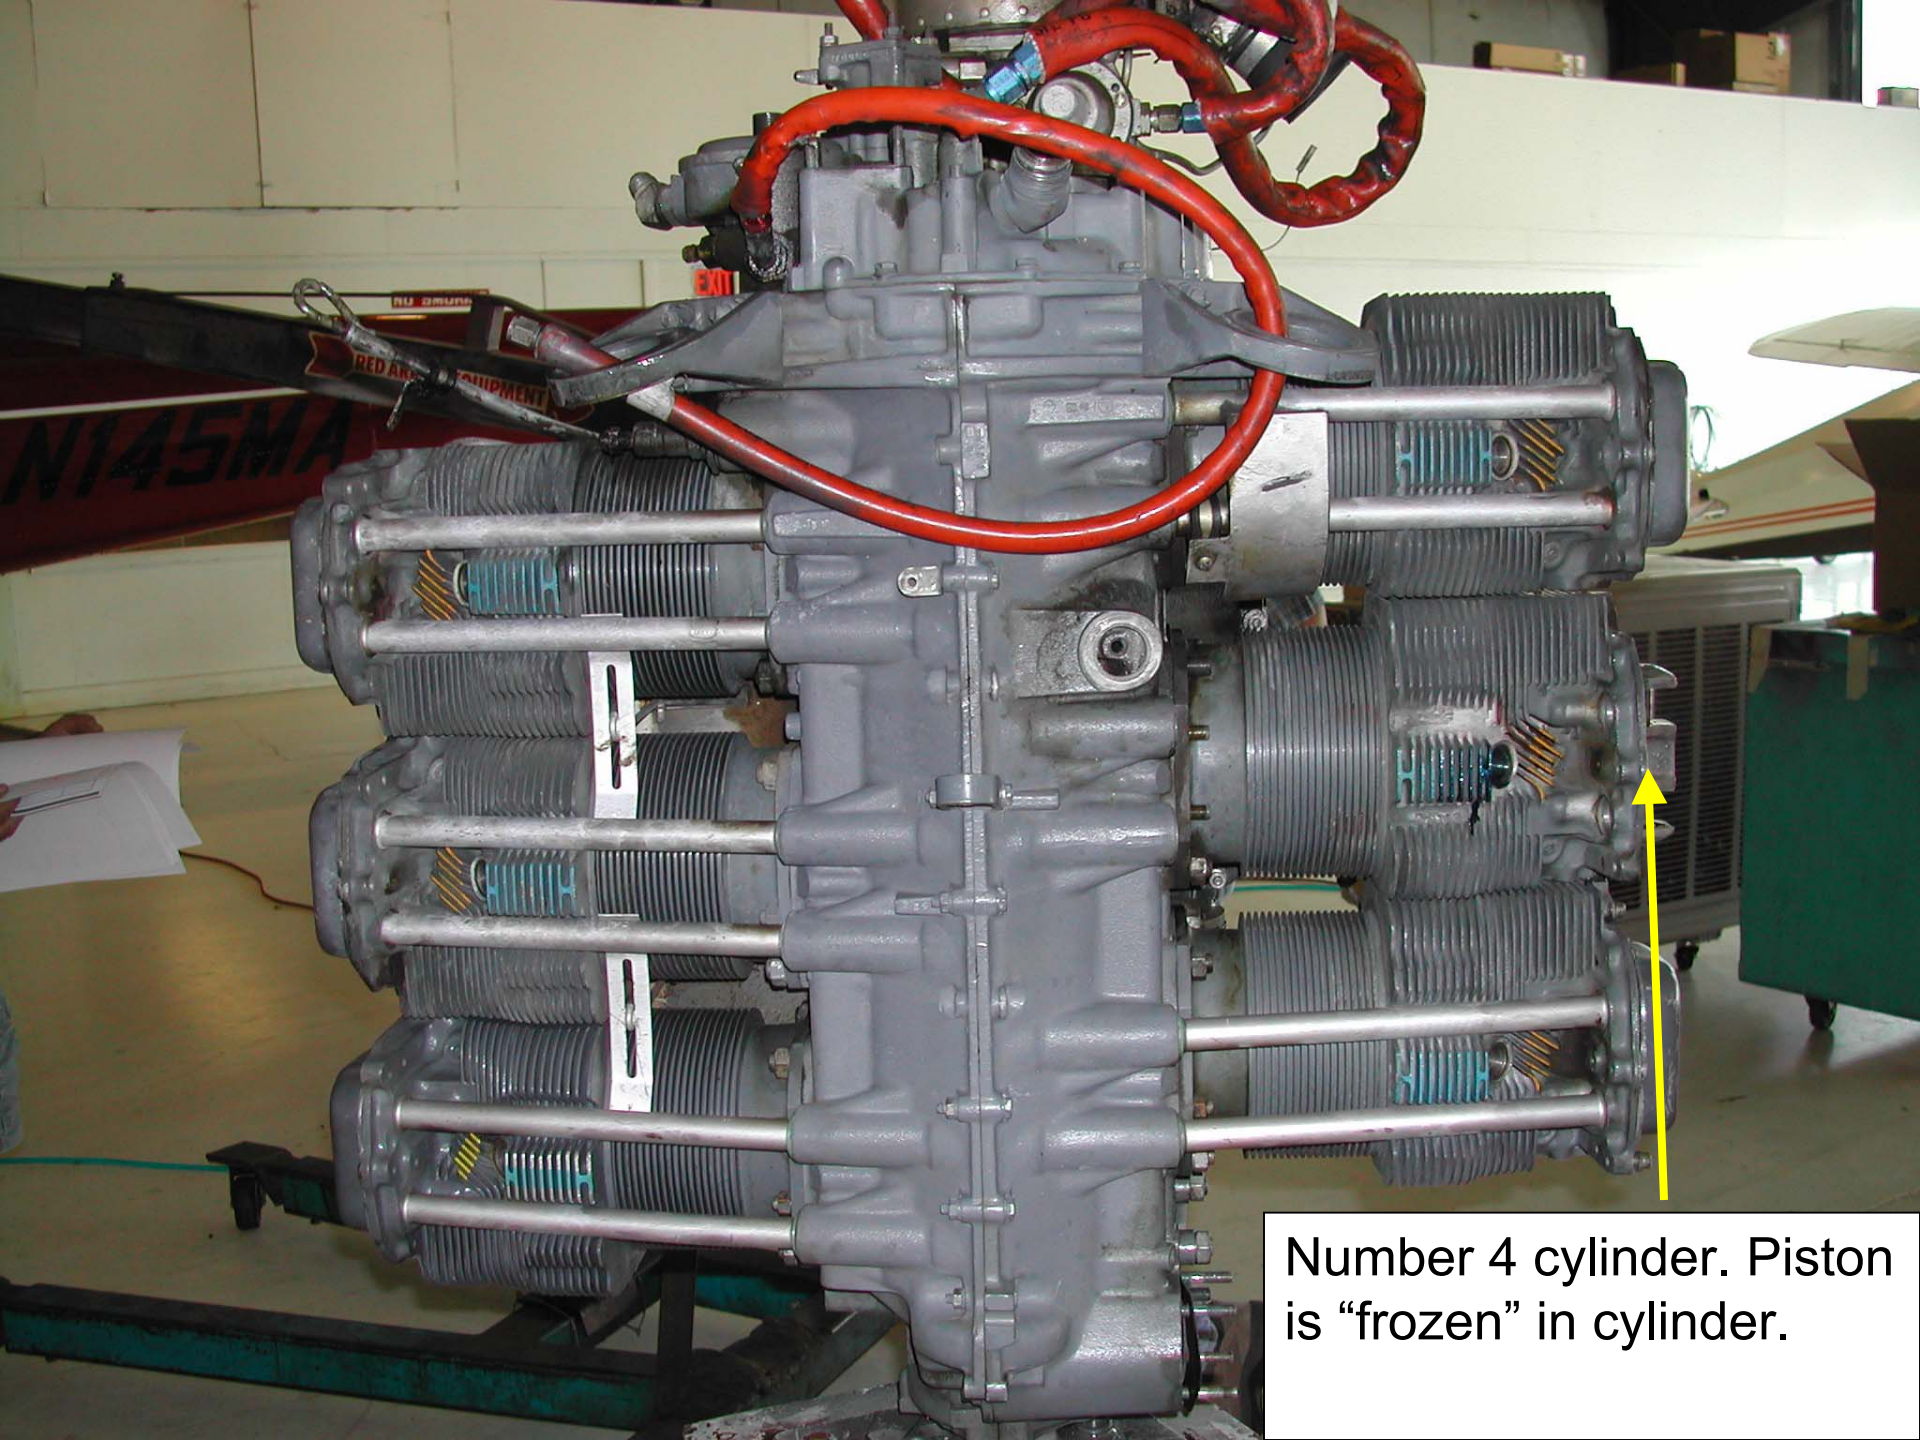
Number 4 cylinder. Piston is "frozen" in cylinder.
